ANNUAL REPORT FOR 2010

Bailey Branch Site D Mitigation Site
Madison County
TIP No. R-2518A

Prepared By:
Natural Environment Unit & Roadside Environmental Unit
North Carolina Department of Transportation
December 2010

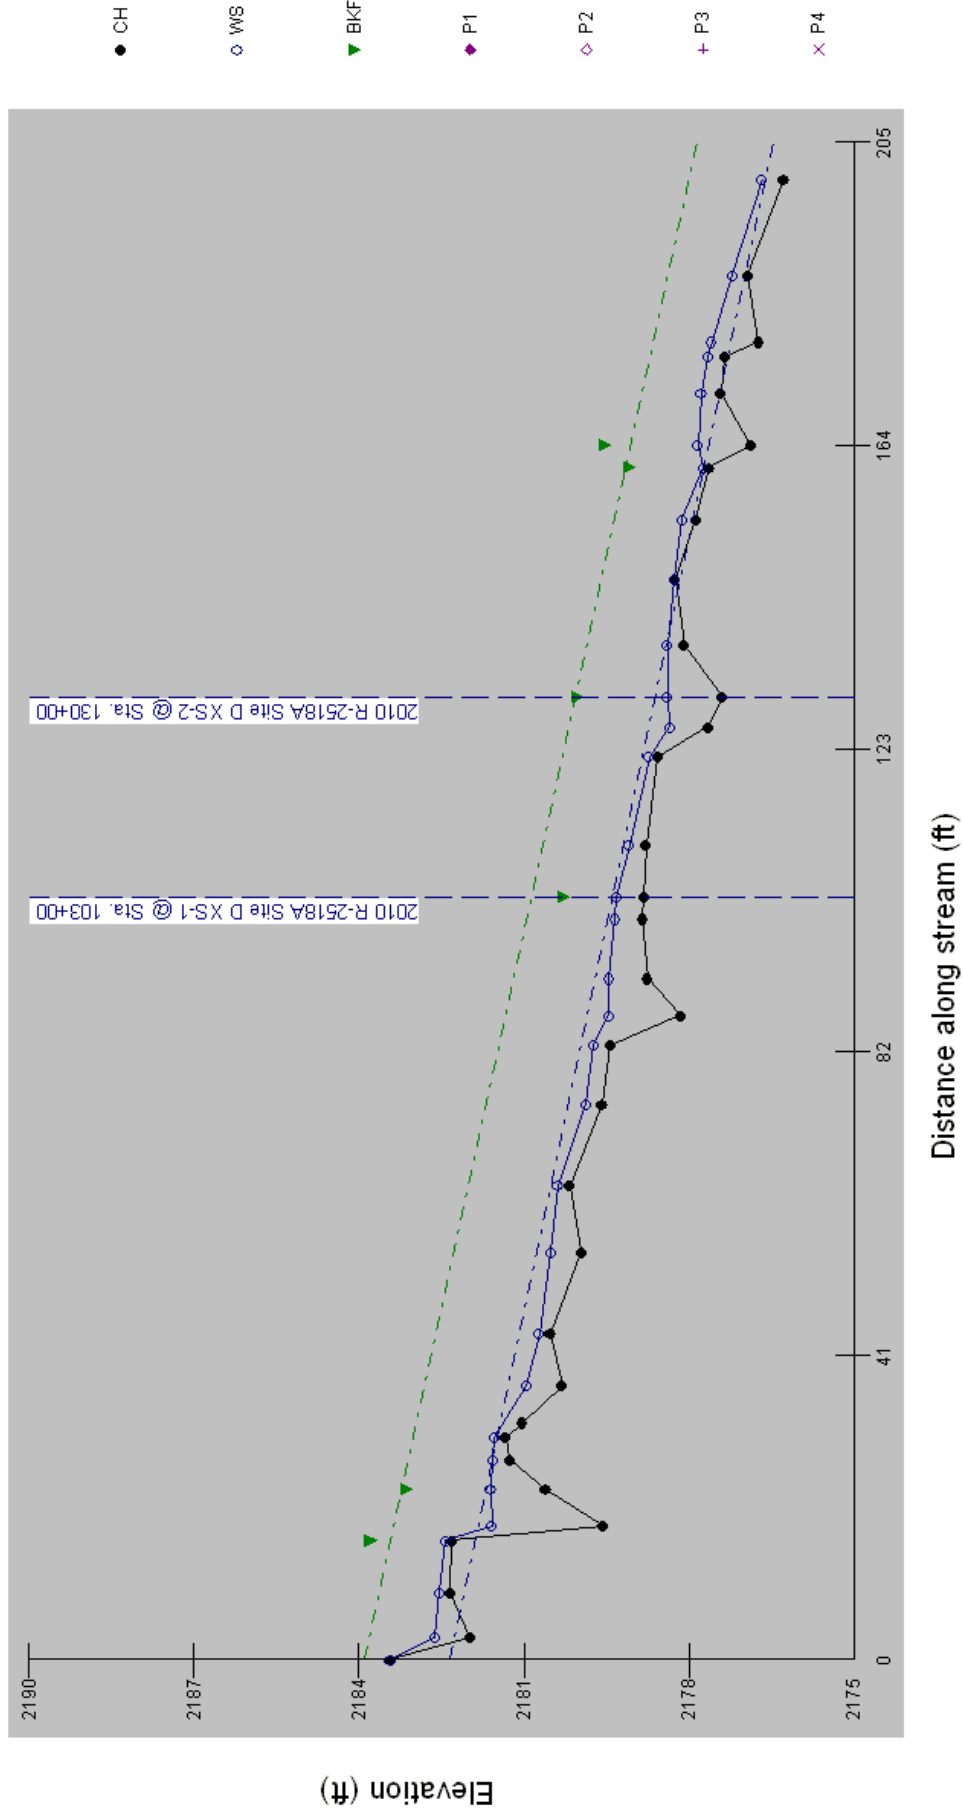
2010 R-2518A Site D Profile

Based on comparisons of the As-Built to Year 1 monitoring data, all of the cross sections appear stable with little or no active bank erosion. Graphs of the cross sections are presented in Appendix A. Future survey data will vary depending on actual location of rod placement and alignment; however, this information should remain similar in appearance. The longitudinal profile showed that the channel was stable for the 2010 monitoring evaluation. Pebble counts were not required per the permit conditions and therefore were not completed.
